**Washington Suburban
Sanitary Commission**

60-Inch Water Main Failure in Chevy Chase and PCCP Program Update April 8, 2013

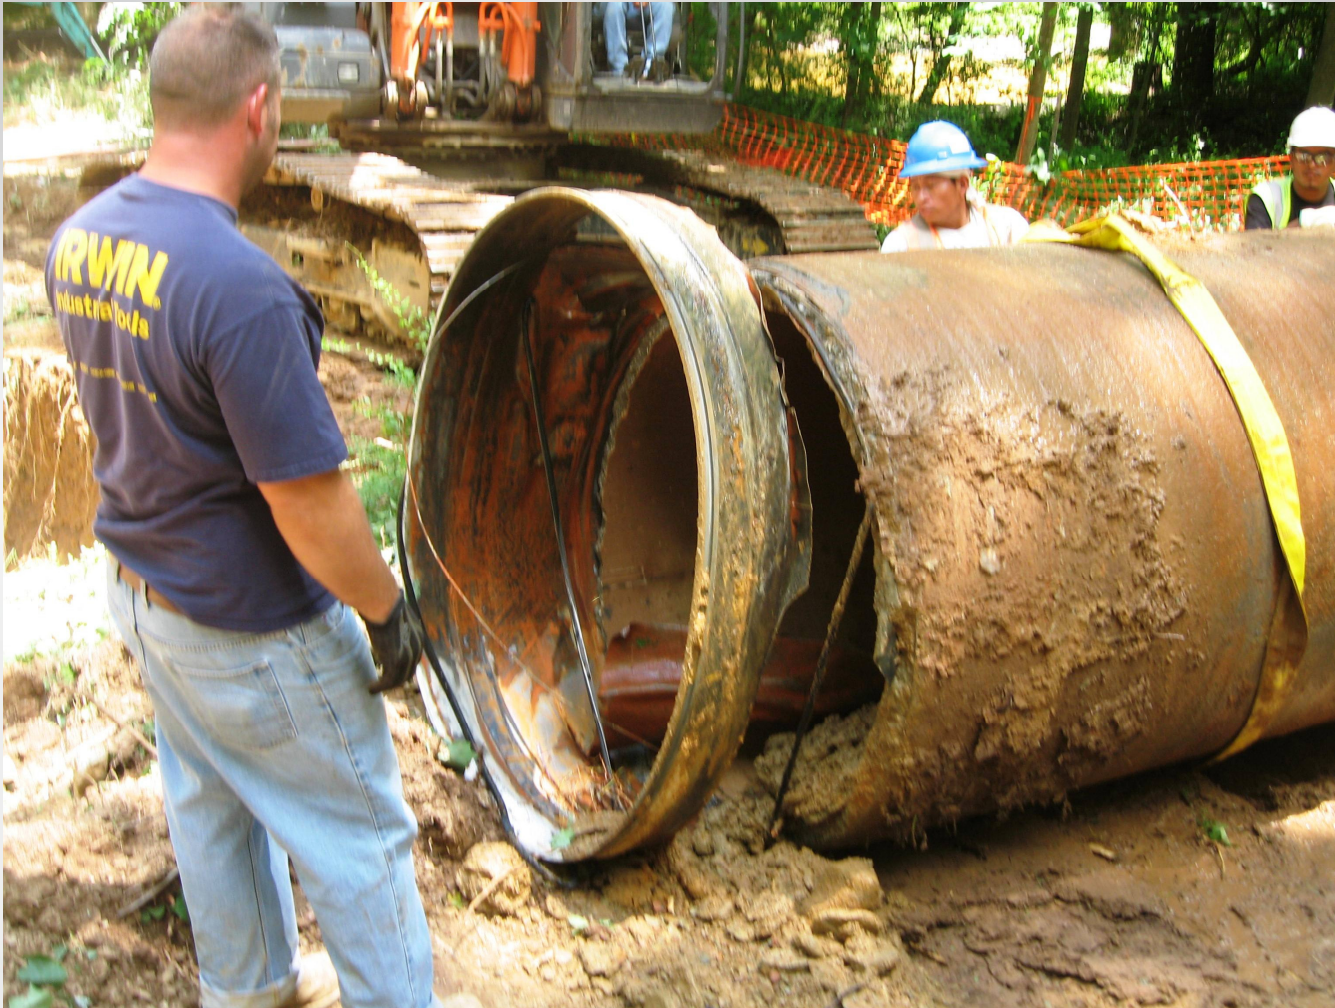
Failed 48-Inch Summer 2008

Shown is Side of Cylinder Rupture.

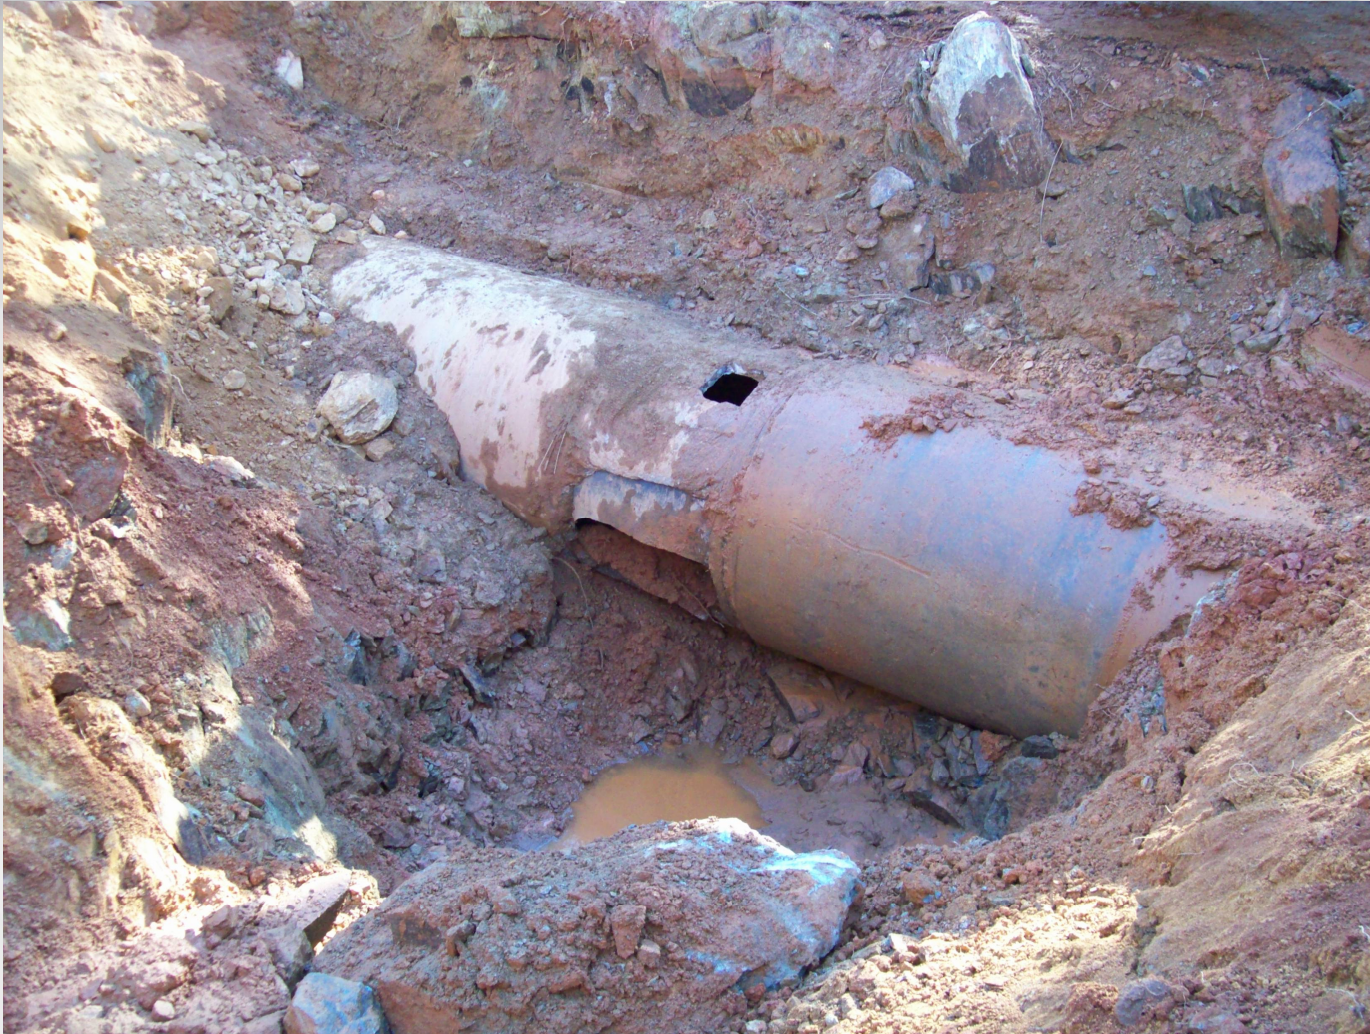
Failed 66-Inch December 2008

Failure is the bottom hole, not the top one & near the joint...

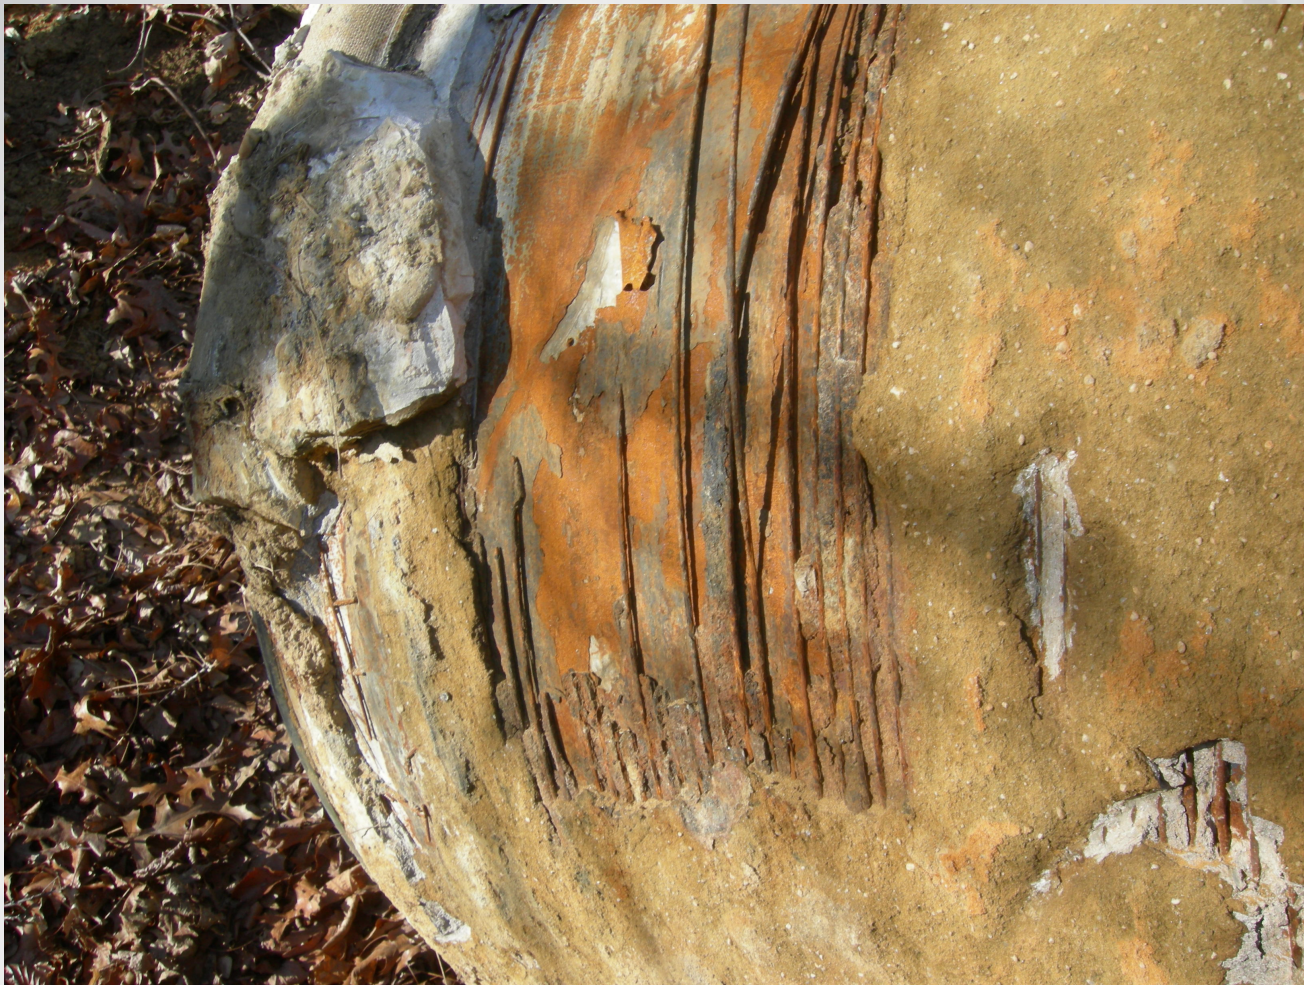
Failed 42-Inch January 2009

Note Failed Wires Showing Corrosion

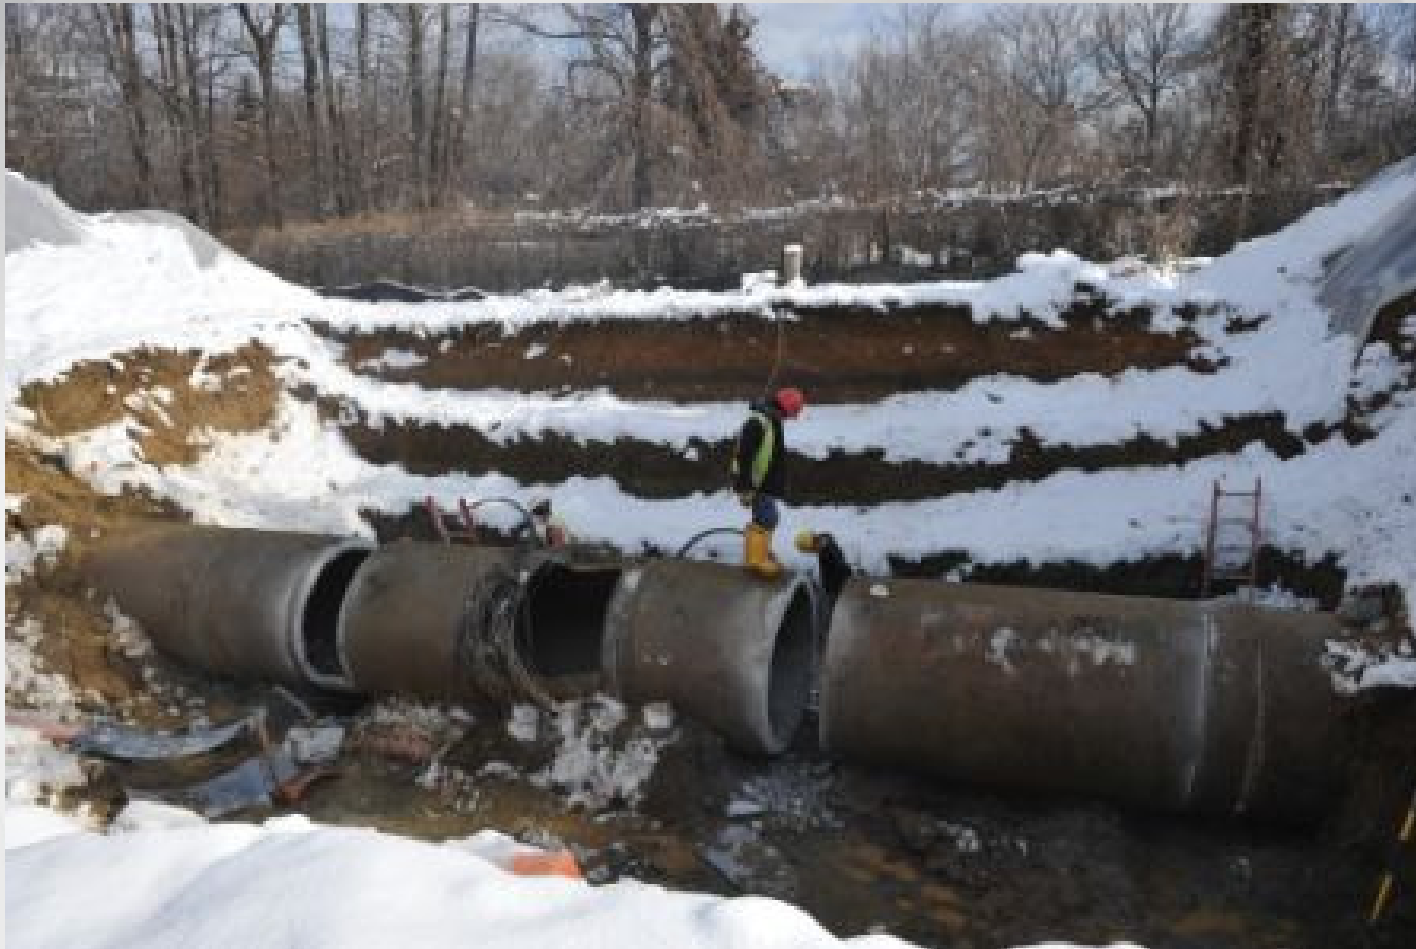
Failed 54-Inch January 2011

After cutting the pipe apart - failure is the second hole from the left

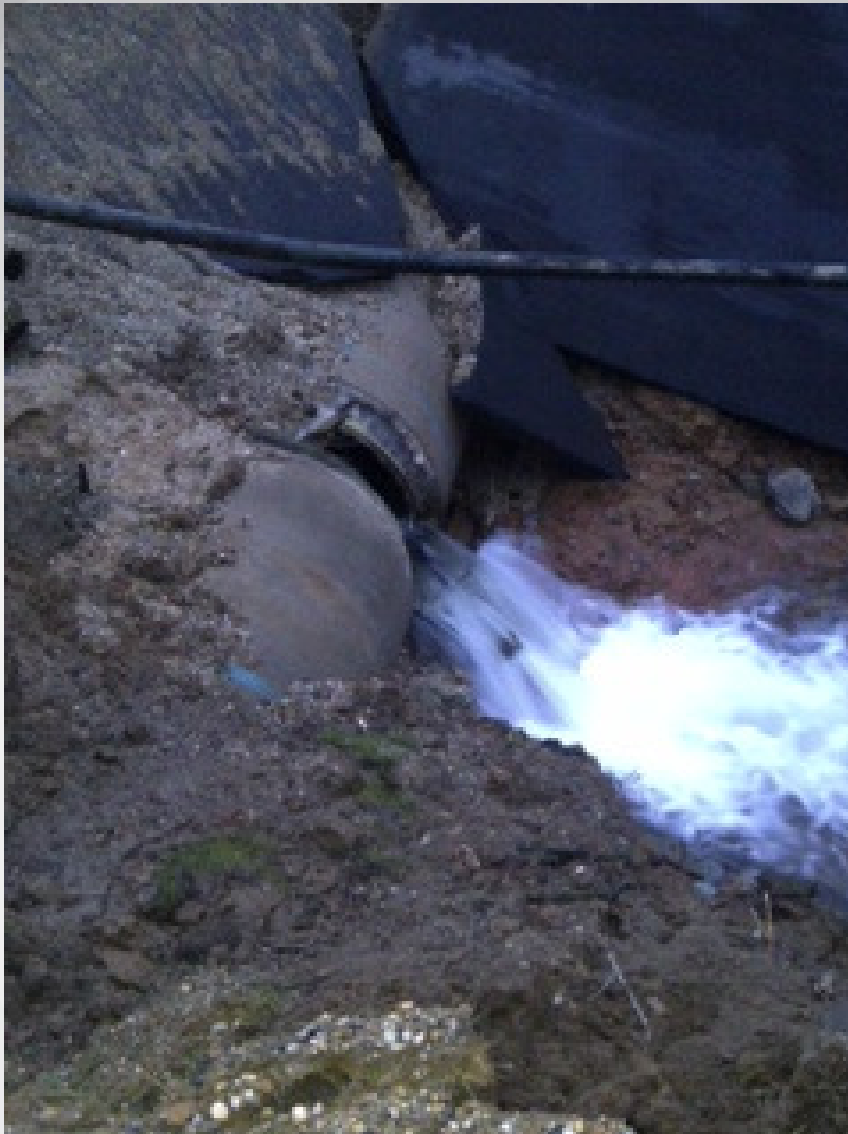
Failed 60-Inch March 2013

Pipeline Runs Approximately Parallel to Connecticut Avenue – Failure Pointed Away From the Road

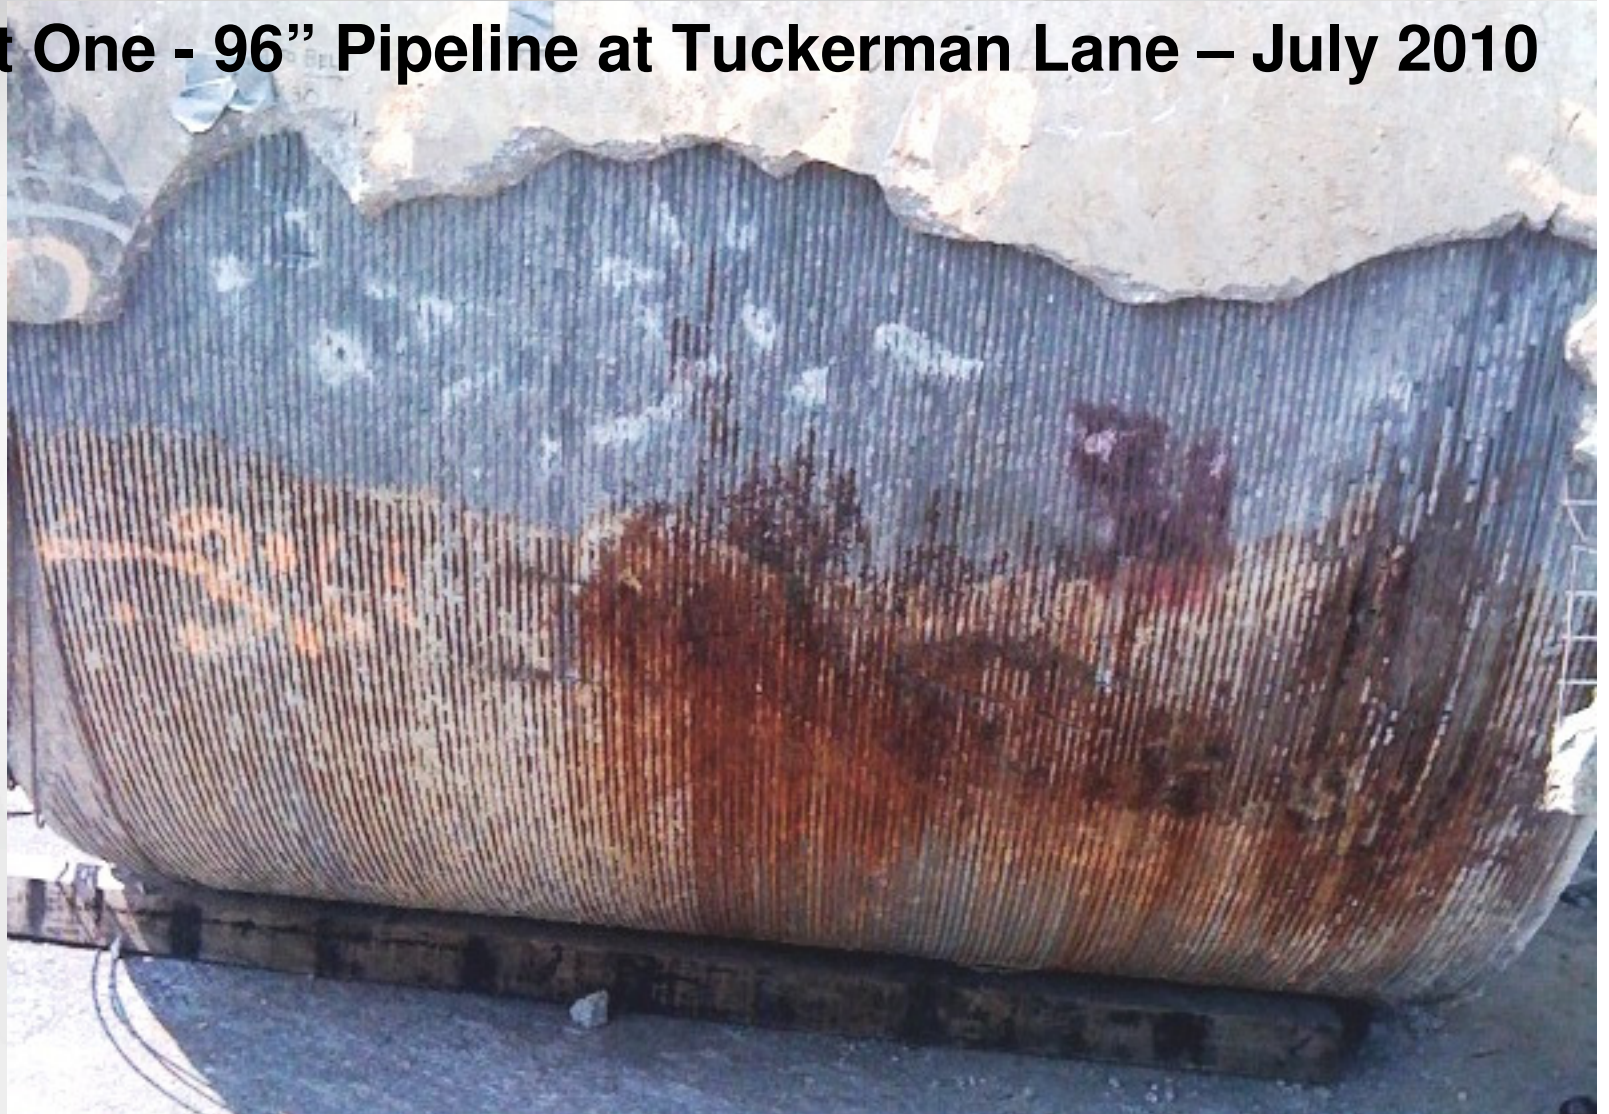
The First One - 96" Pipeline at Tuckerman Lane – July 2010

Does it Work?
